# 2022 Robles Fish Passage Facility Progress Report

Casitas Municipal Water District  
1055 Ventura Avenue  
Oak View, California 93022

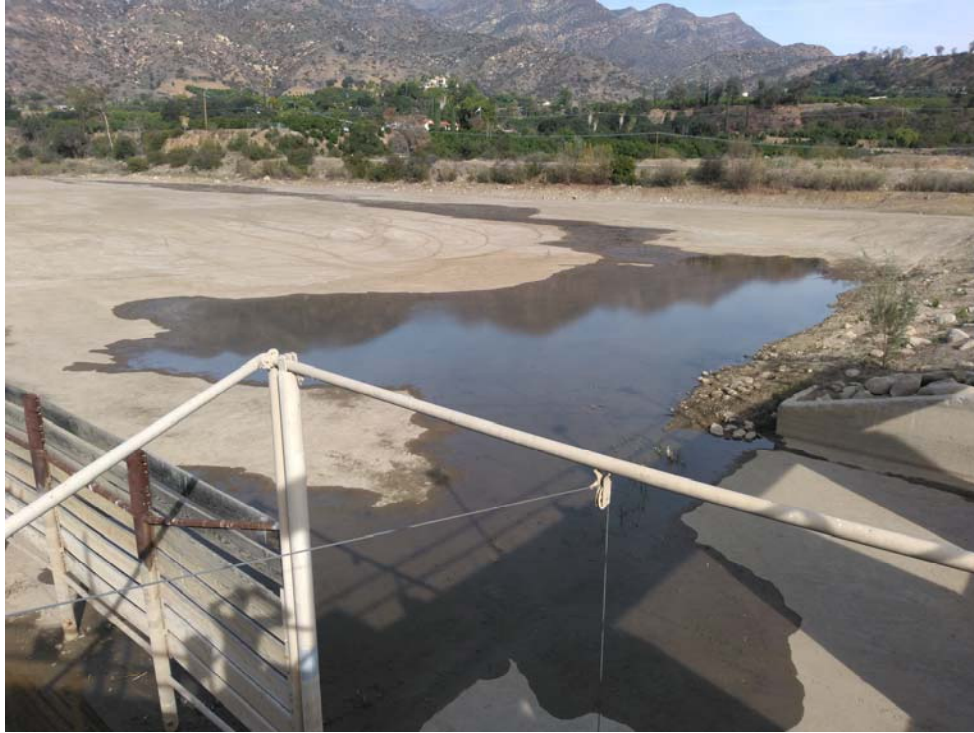
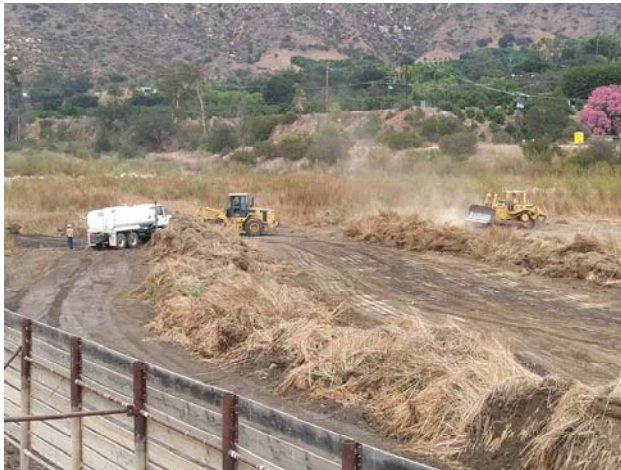
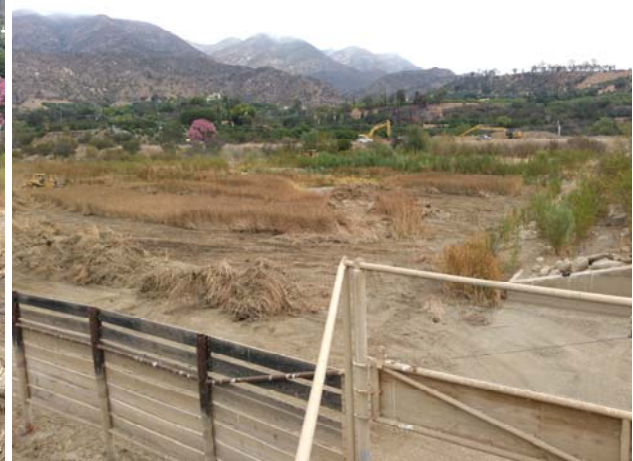
Top photo shows the first surface water arriving in forebay of the Robles Fish Passage Facility in November 2021 after the remaining 15,300 yd<sup>3</sup> of sediment and debris, deposited during the 2019 storms, was removed in September of 2021 (bottom photos).

Forebay sedimentation caused significant operational issues during 2019 and much of the sediment was removed during 2019, the remaining sediment was removed during
