2013 Robles Fish Passage Facility Progress Report

Casitas Municipal Water District
1055 Ventura Avenue
Oak View, California 93022

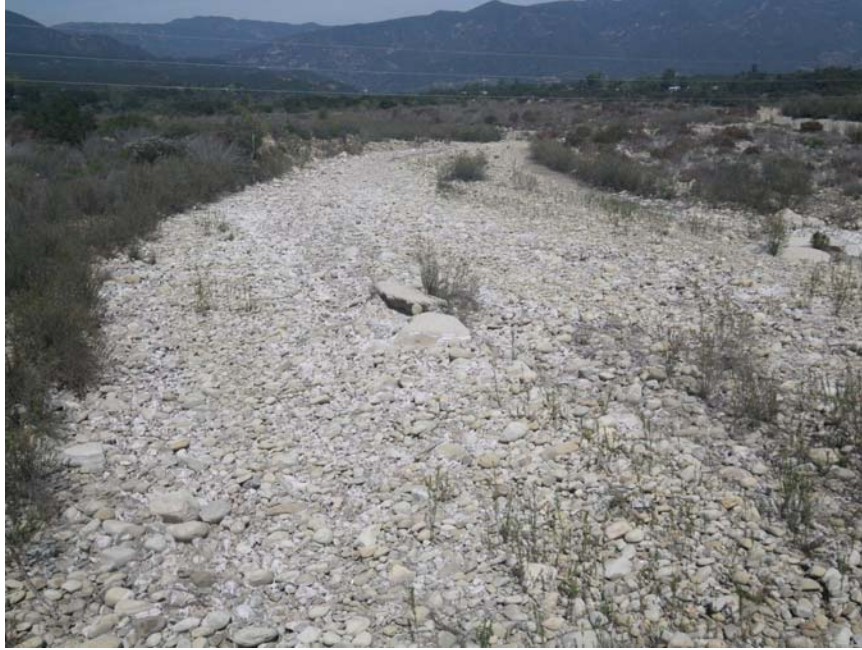
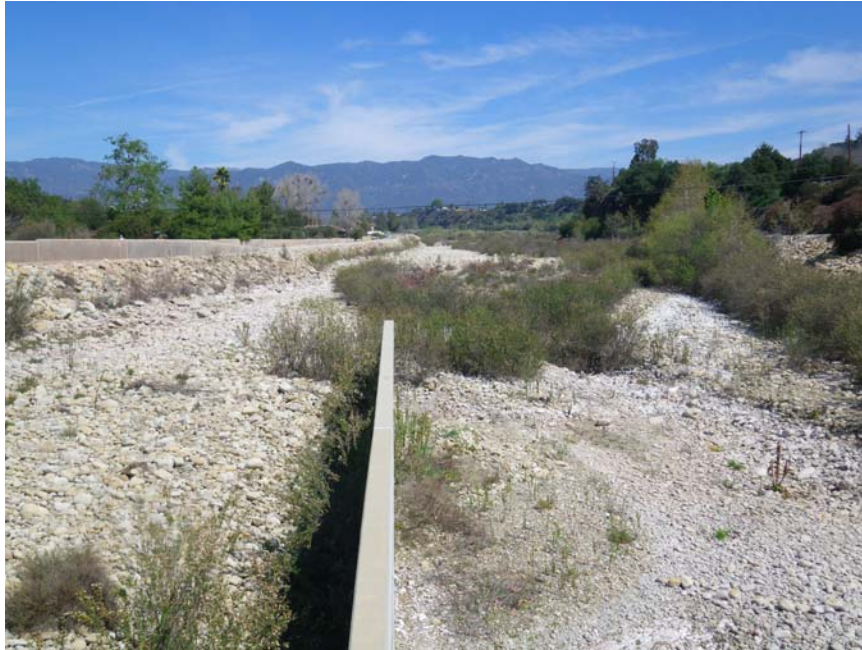
Ventura River channel in the Robles Reach upstream of Hwy 150 (top) and Santa Ana Blvd. (bottom) bridges during March of 2013. Due to low precipitation, the river channel was dry throughout the steelhead migration season.
