2007 Annual Progress Report
of the
Robles Diversion Fish Passage Facility

Casitas Municipal Water District
1055 Ventura Avenue
Oak View, California 93022

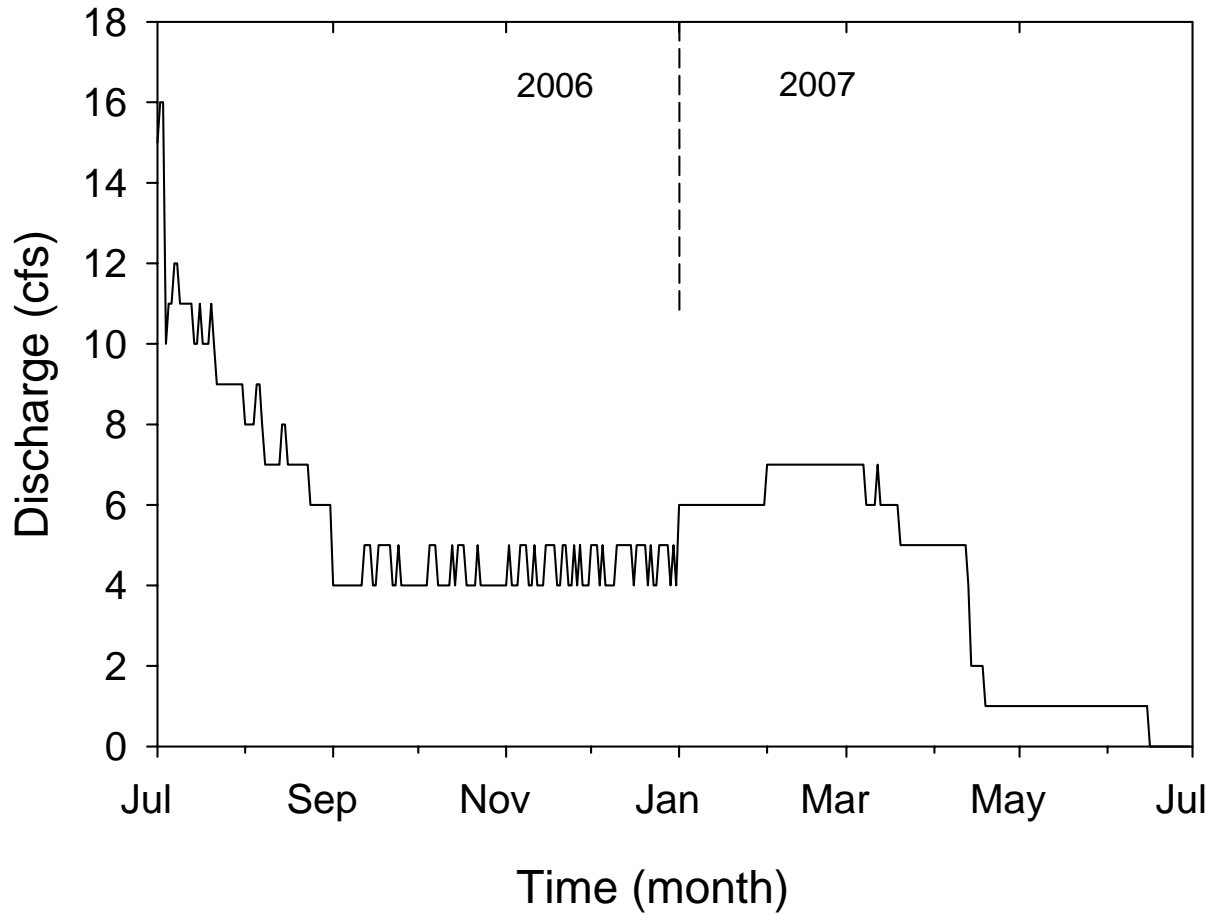
Appendix 4. Discharge (cfs) below the Robles Fish Passage Facility for the reporting period from July 1, 2006 through June 31, 2007.

The crowder and Vaki Riverwatcher were not operated during the reporting period due to the low water conditions. The highest discharge recorded during the period was 16 cfs (Appendix 4) and a minimum of 35 cfs is needed to operate the Riverwatcher. A new fish crowder was designed and constructed and will be operational for the 2007-2008 diversion season (Appendix 5). The new design will have an additional camera to record downstream migrating fish on video. Overall, the new fish crowder is anticipated to improve the monitoring of fish passage through the Robles Facility in several respects that include:

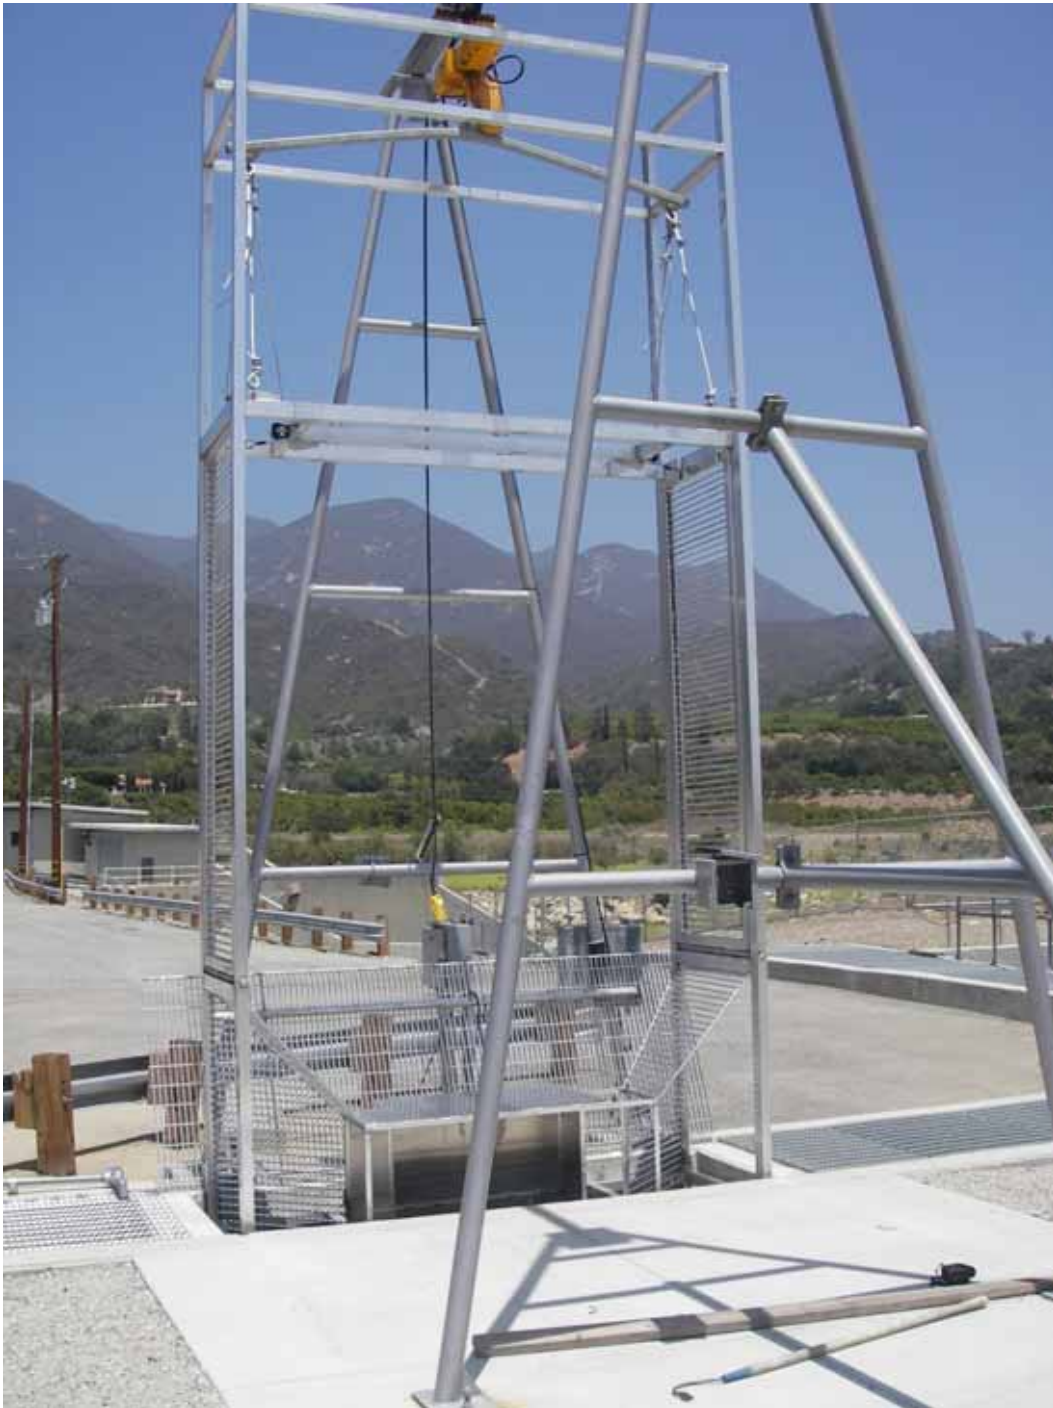
Appendix 5. Photo of the new fish crowder that directs migrants through the Vaki Riverwatcher scanner. The crowder is out of fish bypass and not operational in photo. Also in the photo is an A-frame and hoist that was completed and will allow for easy removal of the crowder for cleaning and repair.

1. New crowder will house the Vaki Riverwatcher scanner near the bottom of the fish bypass so that it may be operated at lower flows (about 10-15 cfs) than the current minimum of approximately 35 cfs.

2. With the scanner closer to the bottom of the fish bypass, it is hoped that the water velocities will be lower, therefore the fish swimming speed will also be lower, and allow for better detection and size estimation by the Vaki Riverwatcher.

3. The new crowder will have a longer scanner section creating better lighting conditions for improved fish detection and identification using the cameras.

4. The longer scanner section will also direct fish better through the camera field of view so that fish lengths can be verified (e.g., to determine the difference between a rainbow trout and steelhead).

5. The addition camera will allow for the verification and identification of fish moving downstream.

Construct New Vaki Shroud – Casitas received a grant from the Pacific States Marine Fisheries Commission through the California Department of Fish & Game to construct a new shroud for the Vaki Riverwatcher. The new shroud will allow for documentation of fish activity down to flows of about 15 cfs. The new shroud will also allow for the addition of a camera to document downstream fish movements. The new shroud was completed in May 2007. Casitas will continue to “fine tune” the new shroud during the summer and fall.
